***“Clean Energy Storage for Grid Load Leveling”
The Metlakatla Battery Energy Storage System
Twelve Years Of Success***

**IRENA CONFERENCE
Srinivas Bharadwaj**

**PORT VILA
JULY 2012**

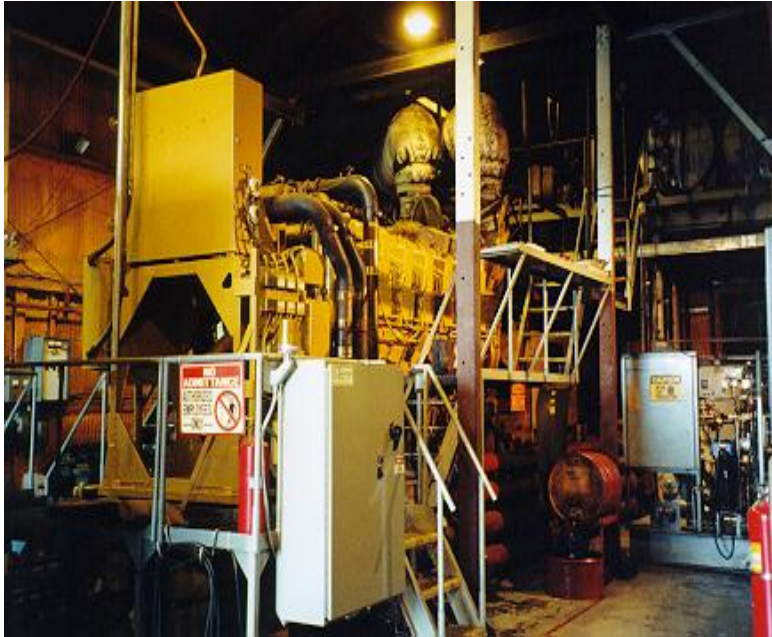
MP&L's Solution

- MP&L installed a \$2 million, 3.3-MW diesel generator
- Operated diesel at 80% capacity to handle load swings and for overall efficiency
- Caused shift of 55% of system load to the diesel
- Fuel usage increased to 475,000 gallons / year in 1996 at a cost of \$400,000 with oil at \$19 a barrel
- Still system problems persisted

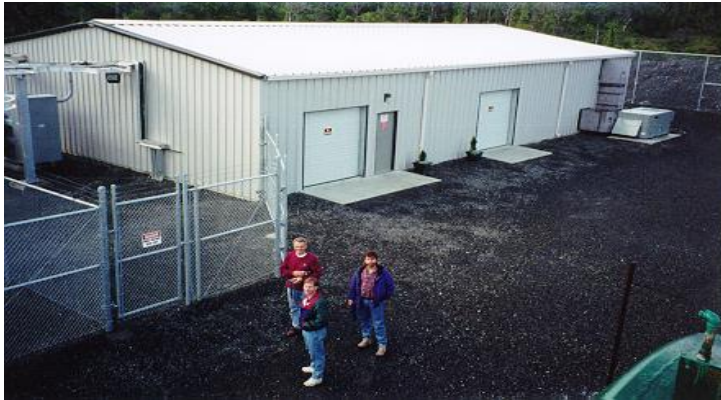
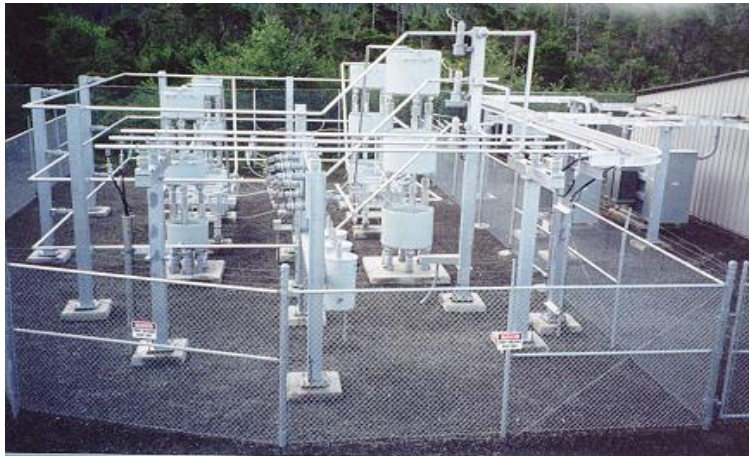
The BESS Solution

- GNB / GE/ Sandia study concluded that a BESS could solve MP&L's problems
- BESS has a nominal load rating of 800 kVA continuous with a peak capability of 1,200 kVA
- BESS connects to the MP&L system at the 12.47-kV switchyard
- A 40 x 70 foot Butler building houses the battery, power conditioning equipment and BESS control room with space for a second battery set
- The entire system was built using readily available commercial industrial equipment

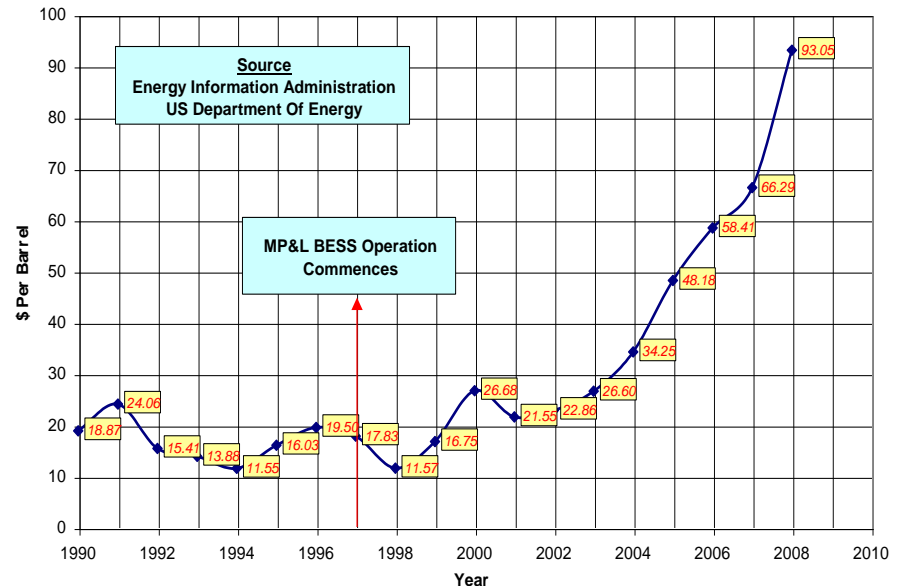
Average annual spot market price for oil (\$/barrel) from DOE data

- Diesel fuel usage remains constant at 1996 level, 475,000 gals/year without BESS
- Diesel use with BESS at 50 gals/hr and 15 days per year
- Base fuel price based on annual spot market average
- Differential between spot market and actual delivered price held constant at 37¢/gal (1996 level)
- Diesel Overhaul (1997–2008):
 - 4 minor / 2 major without BESS
 - 2 minor 1 major with BESS
- Battery Replacement with BESS

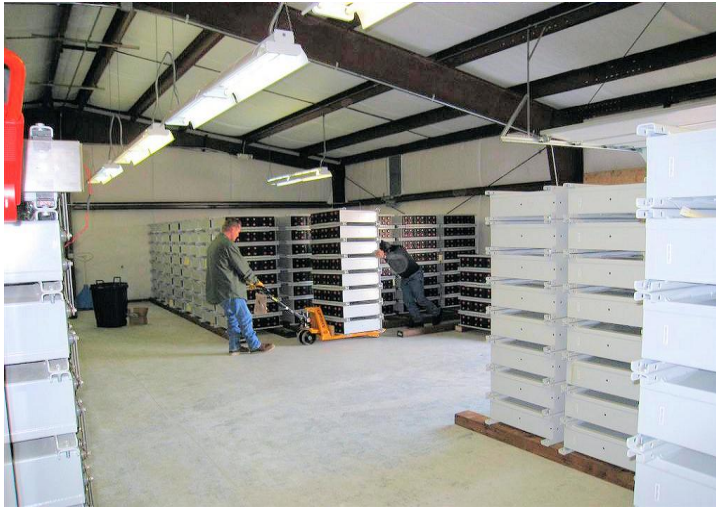
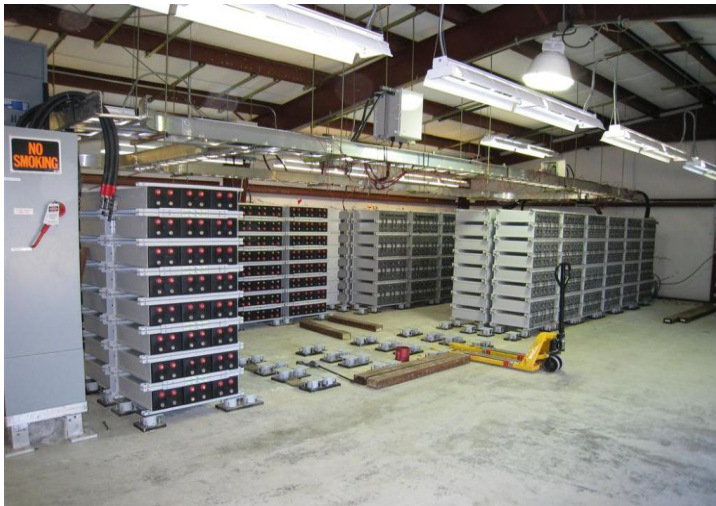
The MP&L BESS Battery – The Changeout

- New modules were unpacked, stacked and pre-assembled
- As stacks of old modules were removed, pre-assembled stacks of new modules were moved into position
- After all electrical connections were made, the new battery was given an equalization charge
- Old modules were packed into the shipping crates and returned to GNB to be recycled
- Total change out effort took 2 installers and 4 helpers, 6 days, working 8-10 hours per day to complete
- Random samples (qty = 36) were sent to GNB for testing and examination

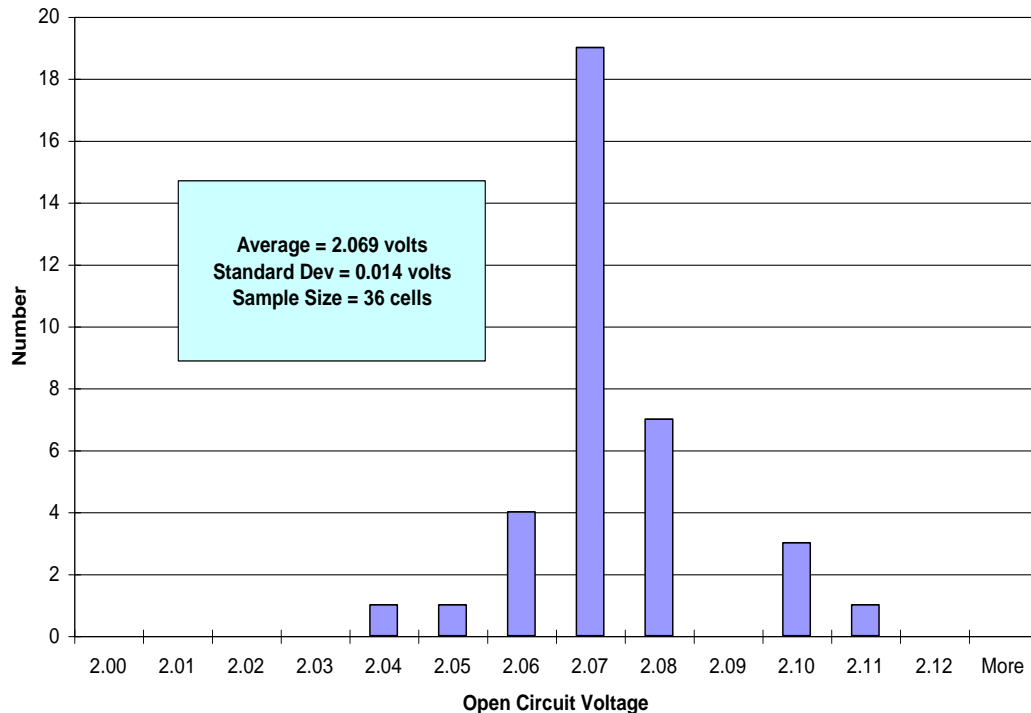
Field-Aged MP&L Cells – “As Removed” Open Circuit Voltage

- Measurements were taken before any other electrical testing
- Cells were removed from the BESS while still in the partial SOC condition
- The average open circuit voltage, 2.07 volts, is consistent with a 50-60% state-of-charge
- The variability among the samples is reasonable considering the BESS was nearing the end of a 6-month operating period

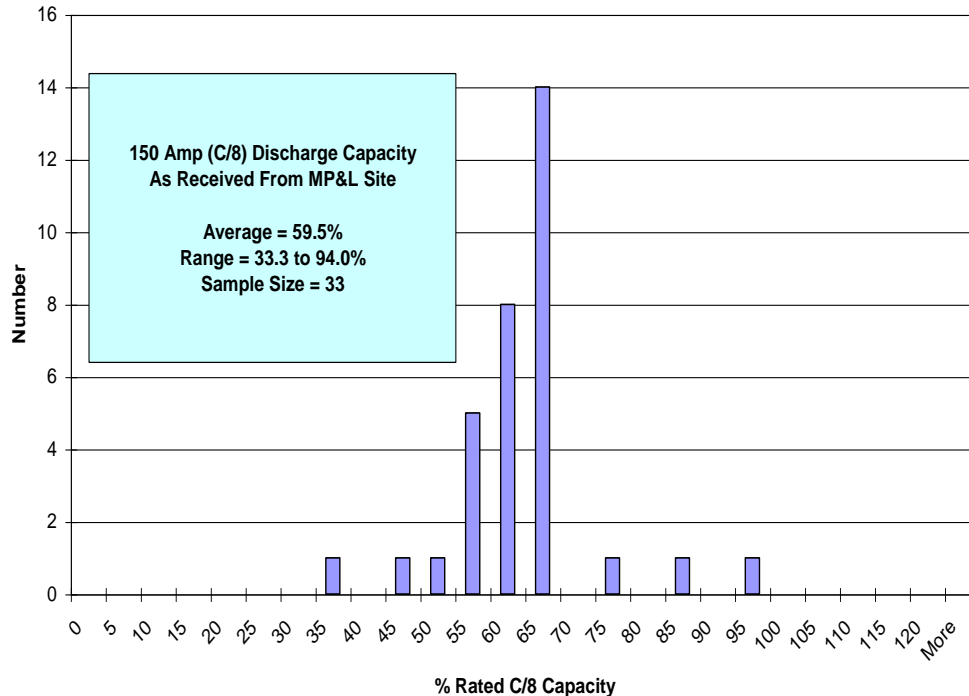
Field-Aged MP&L Cells – “As Removed” C/8 Capacity

- Without any recharge, the MP&L samples were tested at the C/8 discharge rate
- Average capacity was 59.5% ranging from 33.3% to 94.0%
- Capacity correlated well with the measured Open Circuit Voltage
- BESS control algorithm attempts to maintain battery at 50-80% SOC

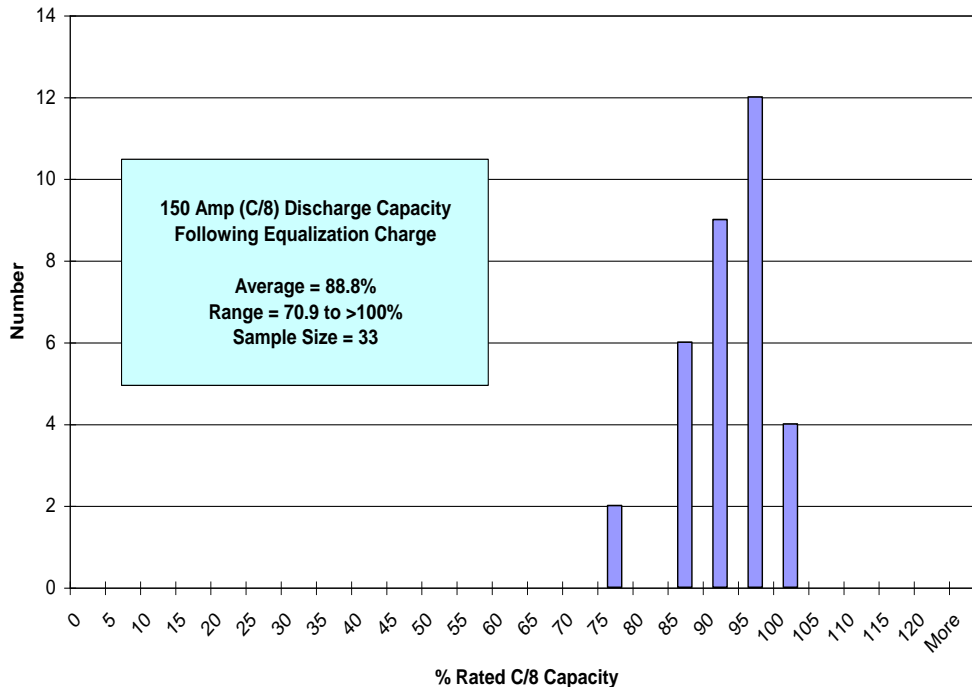
Field-Aged MP&L Cells – C/8 Capacity After Equalization Charge

- The cells were then given an equalization charge, and again discharged at the C/8 discharge rate
- Average capacity rose to 88.8%
- Individual cell capacities all increased ranging from 71% to greater than 100%
- The cells readily recovered from their partial state-of-charge operation

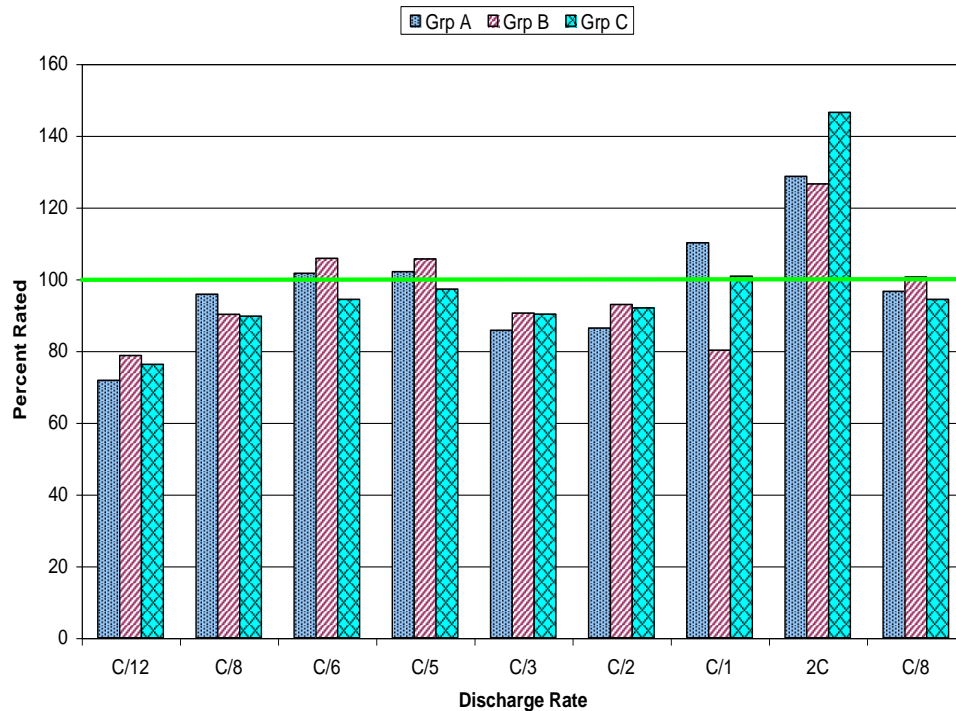
Field-Aged MP&L Cells – At Various Discharge Rates

- The sample cells were grouped into three sets of 6 cells each
- Then discharge tested at C/12 to 2C rates
- Final test was another C/8 discharge
- Overall performance at all discharge rates was greater than 95%
- Even at the 2C (i.e., 30-minute) rate, performance was excellent
- Capacity improved with additional cycling

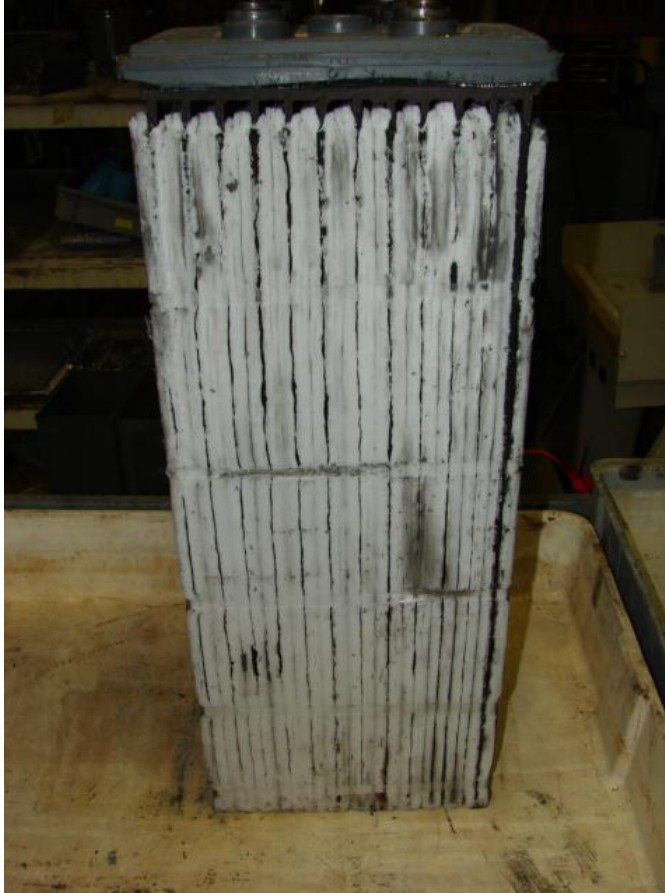
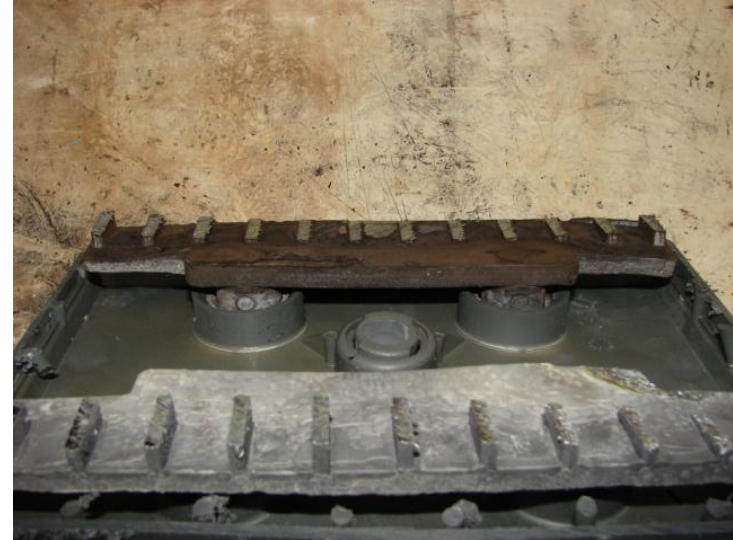
MP&L Cell Exam – Internal Element Assembly

- Cell elements were in excellent condition
- No torn separators; no plate misalignment or growth
- Plate lugs and terminal straps are corrosion free
